AN EVALUATION OF SALMONID HATCHERY WASTES

Danforth G. Bodien

Federal Water Quality Administration
Portland, Oregon

October 1970

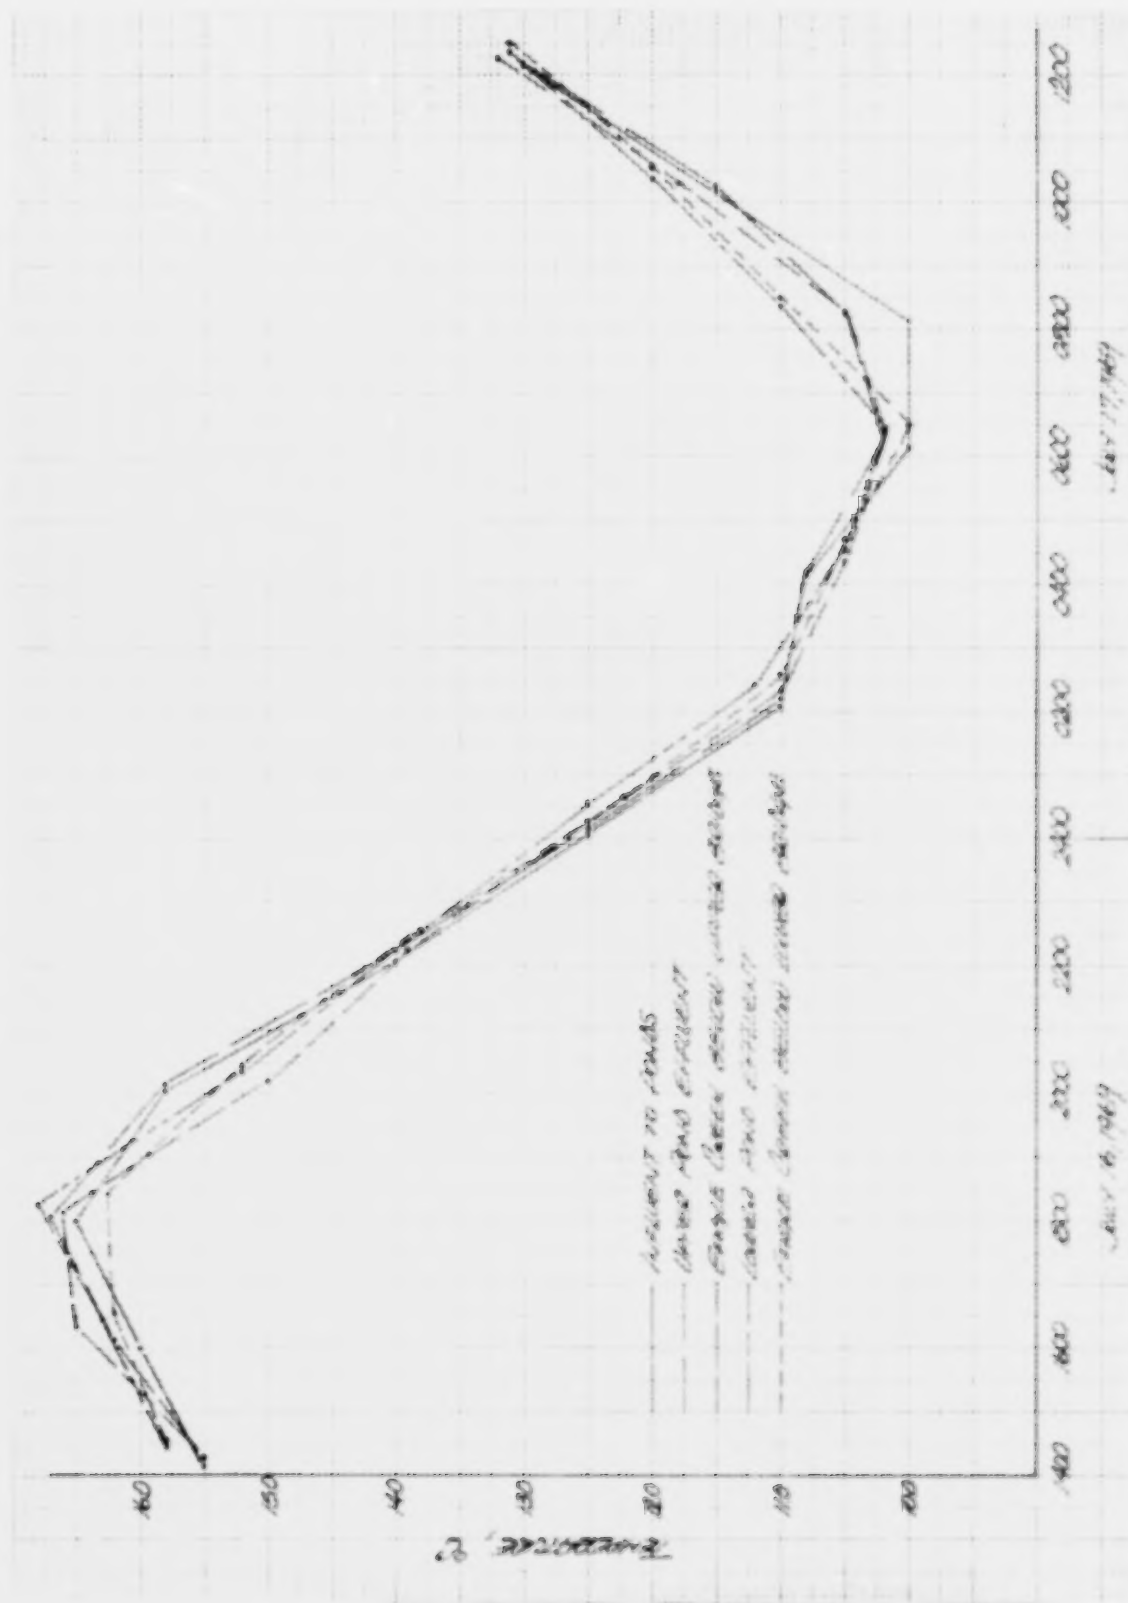
FIGURE 2. Journal Temperature Curves for Five Stations at the Eagle Creek Hatchery.

Figure 2 shows a daily record of temperature for five sampling stations at the Eagle Creek Hatchery. This record shows a rather large (6.5°C) diurnal change in temperature. No significant change in temperature is noted through the hatchery.

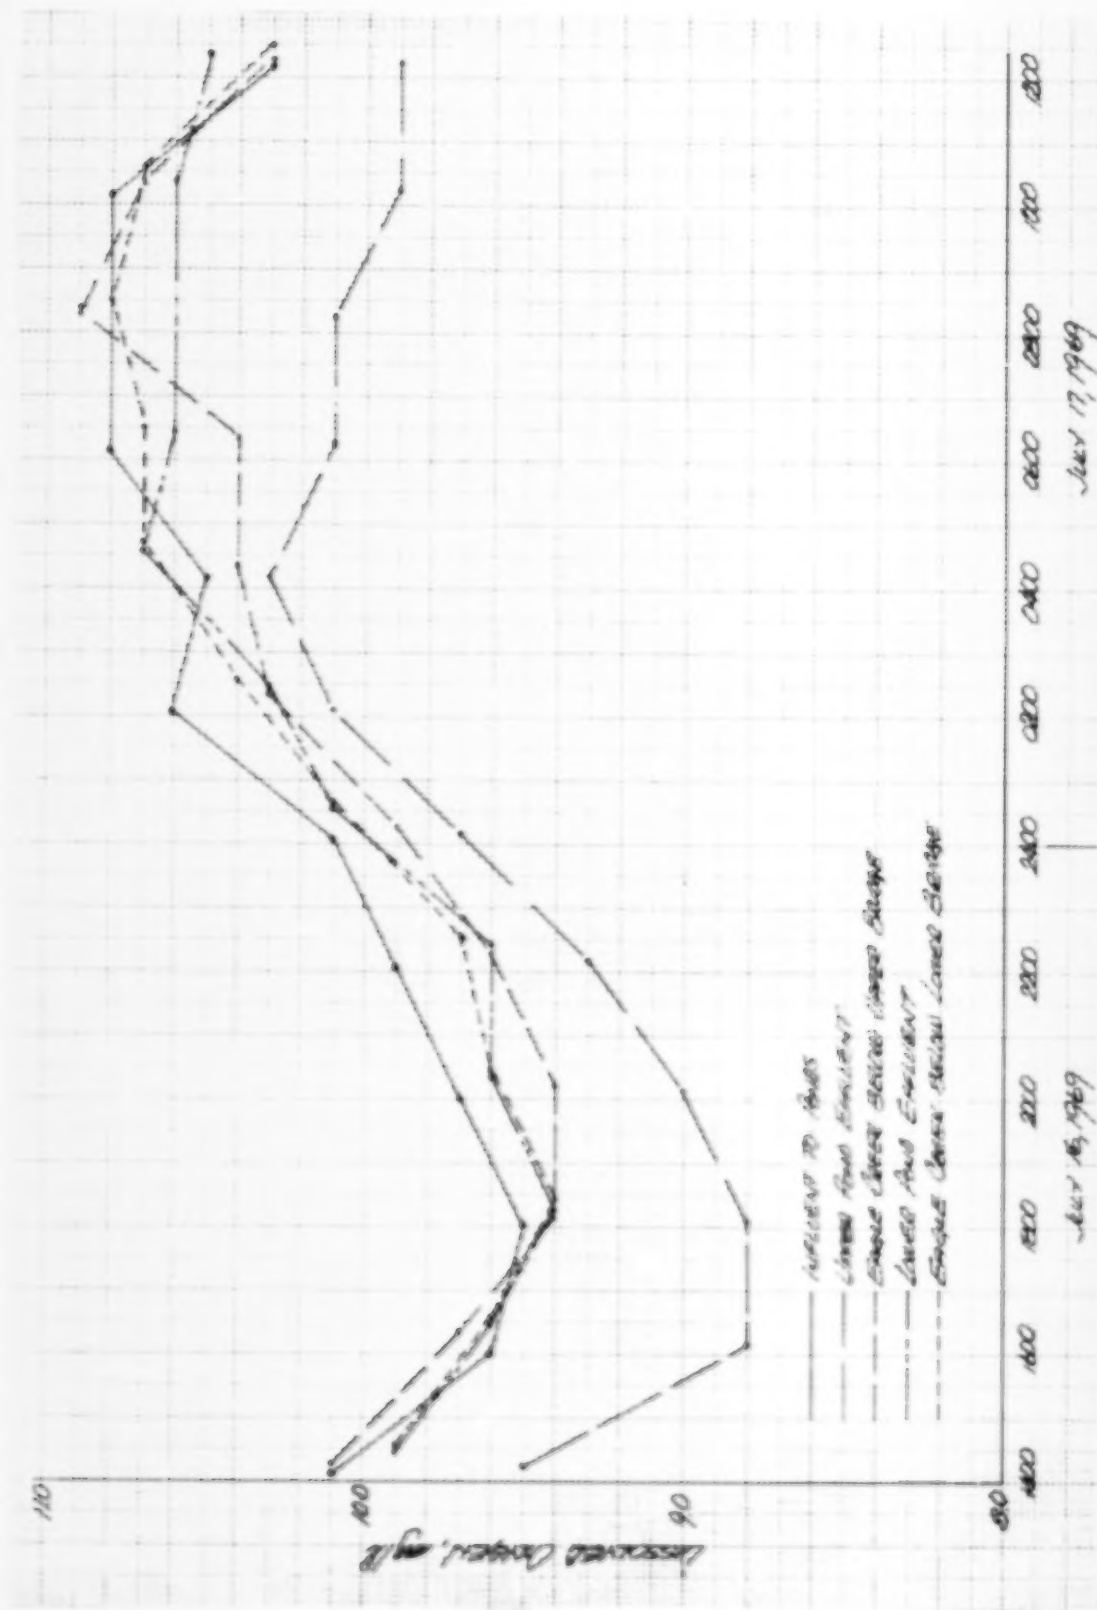
FIGURE 3. Diurnal Dissolved Oxygen Curves for Five Stations at the Eagle Creek Hatchery.

Concurrently with temperature, dissolved oxygen was measured every two hours at Eagle Creek. Figure 3 indicates results of these analyses. While no significant change is noted through the total hatchery, a definite decrease is shown through the upper ponds. Figure 4, which indicates only the upper pond influent and effluent DO's, shows this most clearly. Here, an average decrease of 0.6 mg/l for the period surveyed can be noted. The reason that a similar decrease was not measured through the lower pond is that the lower pond effluent passes through a holding basin (which contains three small aerators) and through the fish ladder before it is discharged to Eagle Creek.

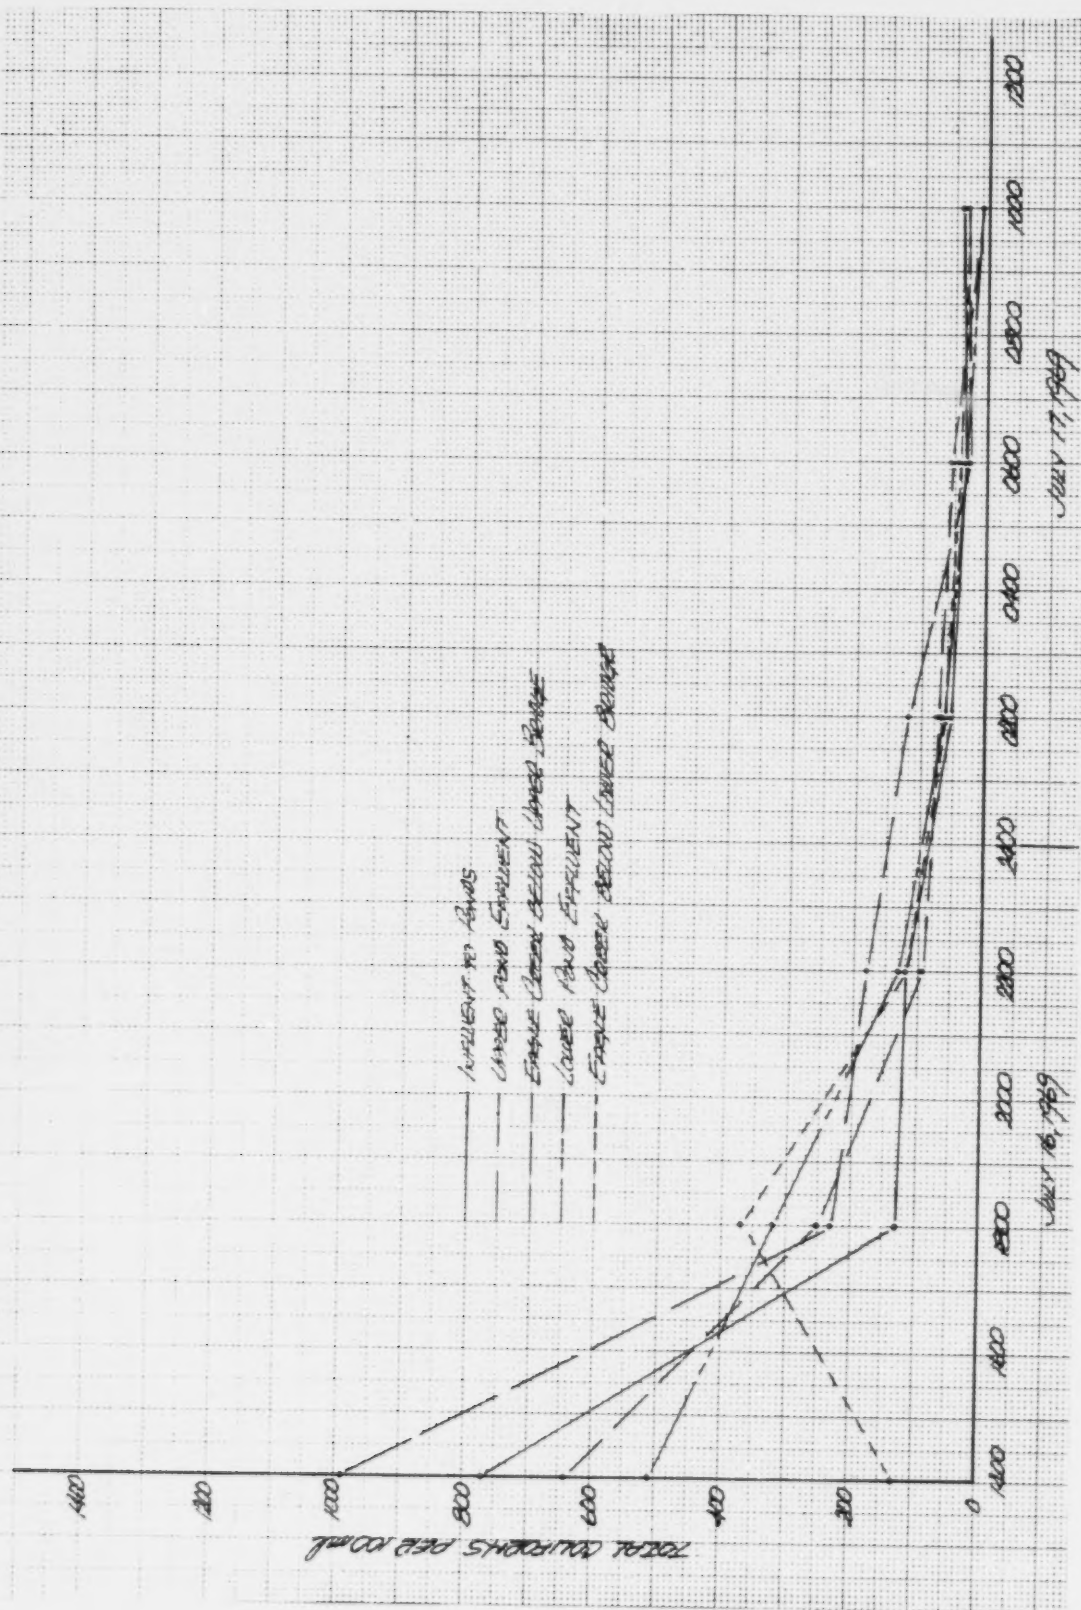
FIGURE 5. Diurnal Total Coliform Counts for Five Stations at the Eagle Creek Hatchery.

Bacteriological samples were taken during the 24-hour study at Eagle Creek. Samples were collected every four hours and analysed for total and fecal coliforms. Figure 5 shows total coliform counts for the five sampling sites. The data show that a source of contamination existed above the hatchery during the first few hours of sampling. Comparison of values from above and below the hatchery suggests that regrowth of coliforms may be occurring as a result of the hatchery discharge.
